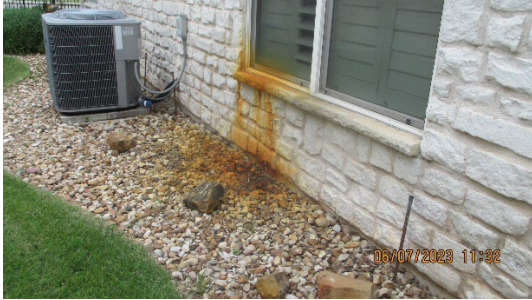
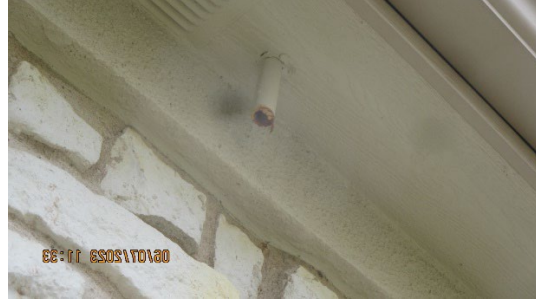
The tube coming out of the soffit is the secondary drain for your AC condensation. The secondary drains on homes with the condenser in the attic always have the secondary drain outlet positioned over a window so that the homeowner will notice it dripping.

The primary drain empties directly into your sewer pipes or vent. When it becomes clogged, water will empty through the secondary drain to prevent your ceiling from being ruined from the water overflow.

You should have a qualified person clear your primary drain line as soon as possible. Also, the Sun City Design Guidelines specify that the exterior house surfaces must be maintained to keep a neat and attractive appearance. Therefore, the stonework discolored by the dripping condensate must be cleaned up.

Please note that if you routinely pour a mixture of white vinegar and warm water down the PVC pipe that is your primary drain, you can prevent future clogging. I don't recommend you going up into the attic to do this, but you should be able to find a young person to take care of the task for you.
